# Miller's Bay, Lake Winnebago

## Aquatic Plant Management Plan

August 2010

**Miller's Bay, Lake Winnebago**  
Winnebago County, Wisconsin  
**Aquatic Plant Management Plan**  
June 2010

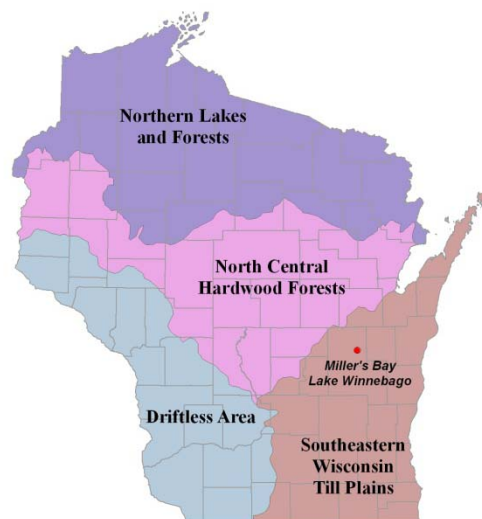
**Figure 1. Location of Miller's Bay within the ecoregions of Wisconsin.** After Nichols 1999.

Floristic Quality Assessment (FQA) is used to evaluate the closeness of a lake's aquatic plant community to that of an undisturbed, or pristine, lake. The higher the floristic quality, the closer a lake is to an undisturbed system. FQA is an excellent tool for comparing individual lakes and the same lake over time. In this section, the floristic quality of Miller's Bay is compared to lakes in the same ecoregion and in the state (Figure 1).

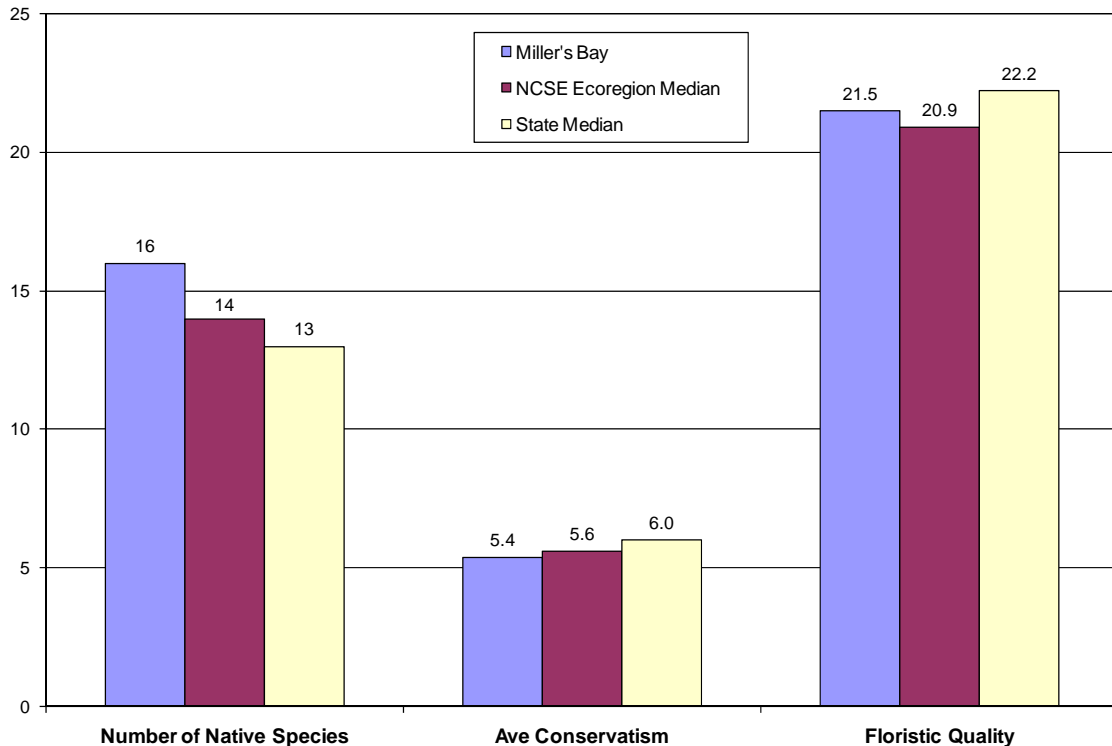
**Figure 3. Miller's Bay Floristic Quality Assessment of 2008 survey data.** Analysis following Nichols 1999.

As mentioned above, Miller's Bay contains slightly more aquatic species than the state and ecoregion medians. The Miller's Bay average conservatism values are considerably lower than the state and slightly lower than the ecoregion medians (Figure 3). This indicates that many of the species present in the bay are indicative of a disturbed system. Combining the species richness and average conservatism values results in a moderate floristic quality for the bay that is just slightly higher than the ecoregion median and slightly lower than the state median (Figure 3).

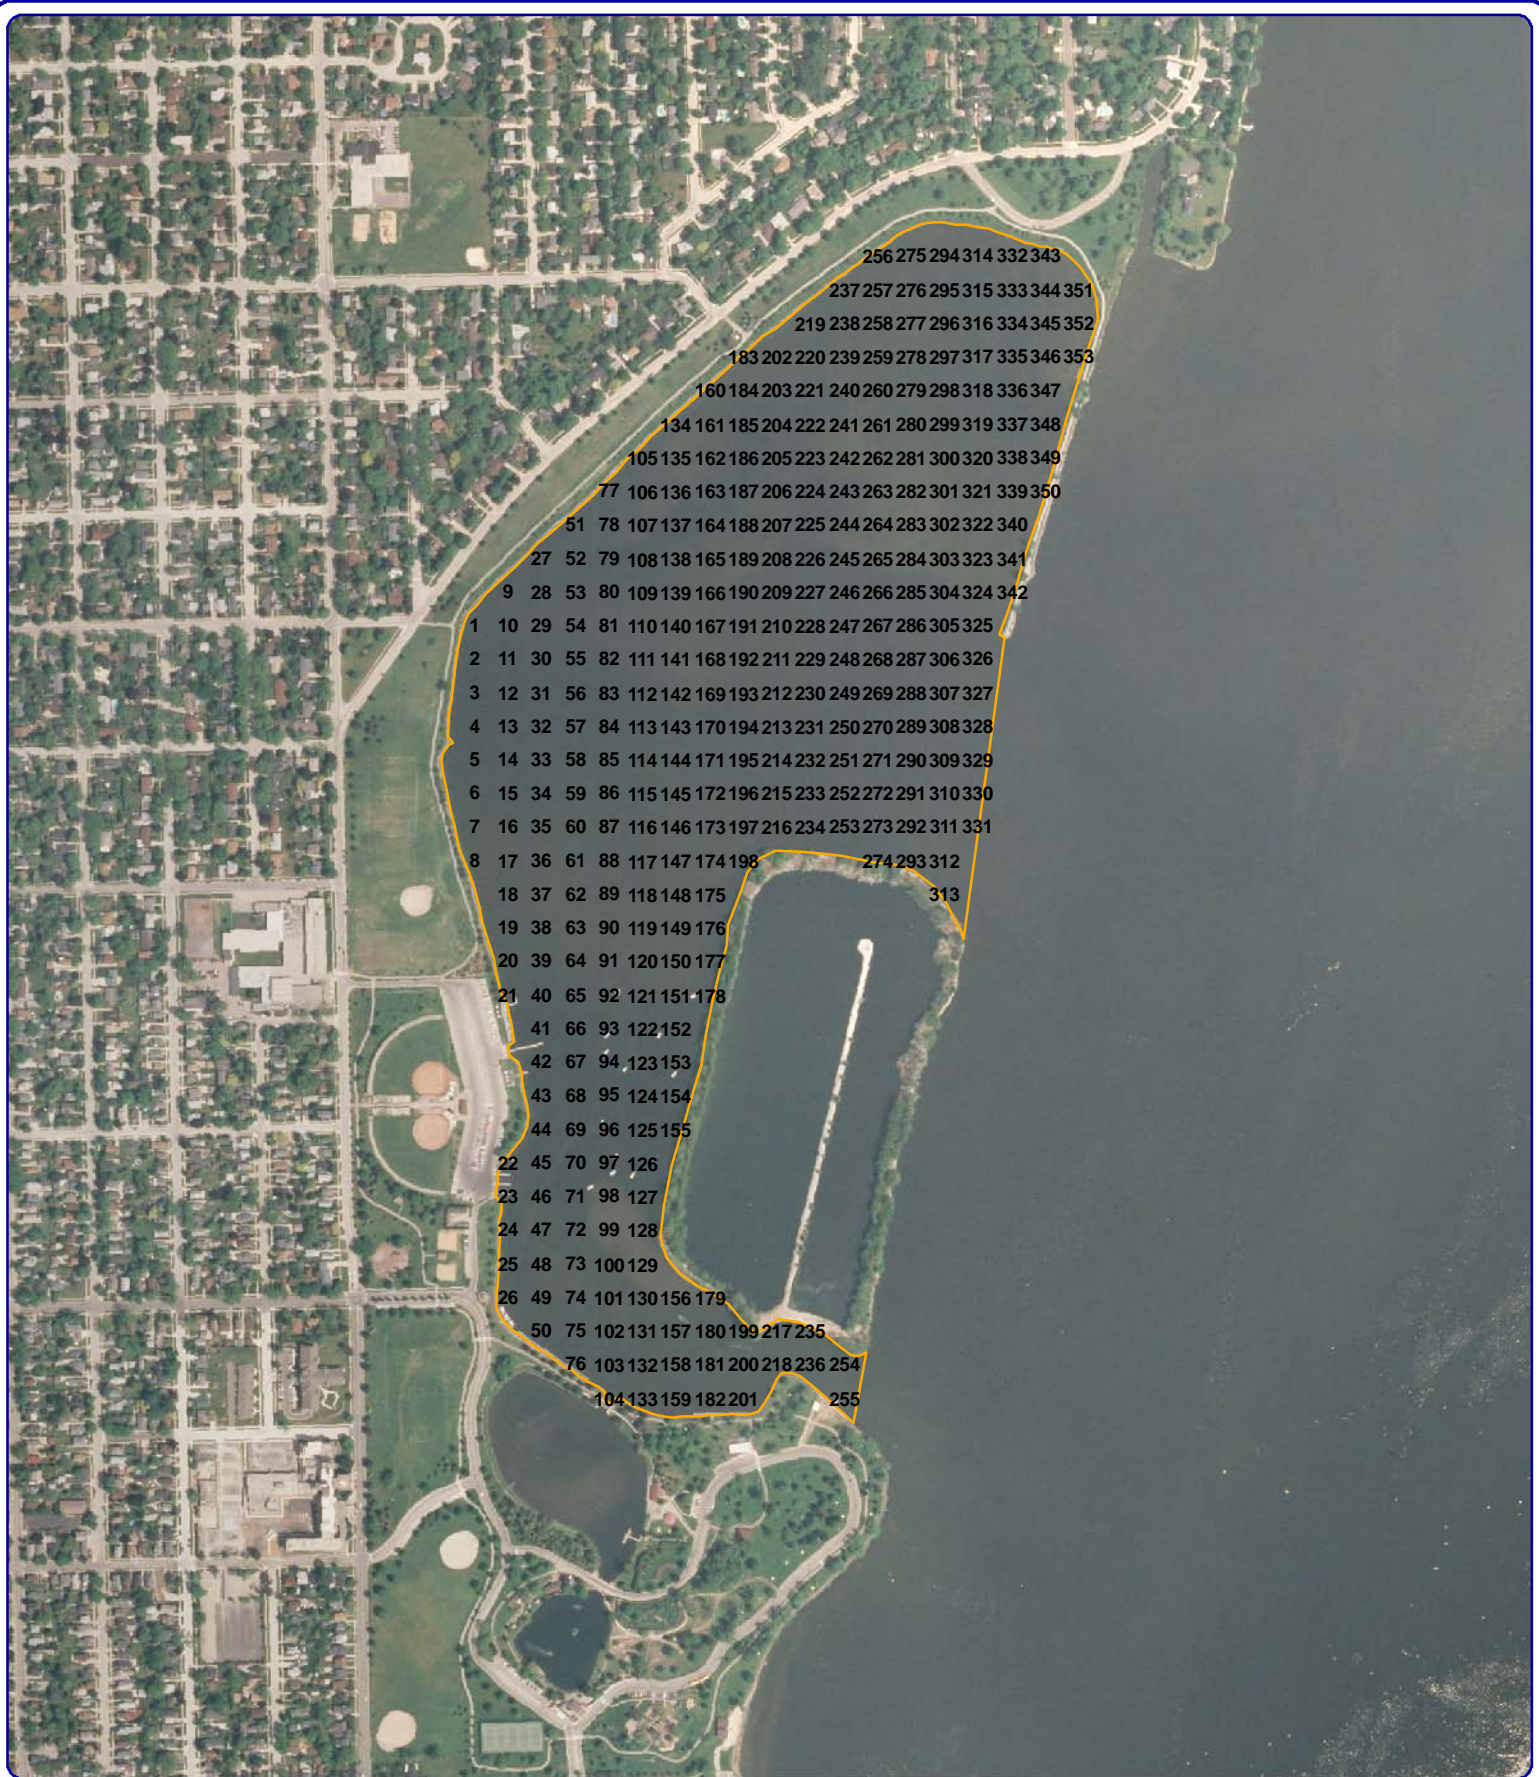
- # Point-Intercept Plot (40-Meter Spacing)
- Millers Bay Project Limits

**Map 1**  
**Miller's Bay**  
 Lake Winnebago  
 Winnebago County, WI  
**Project Area**

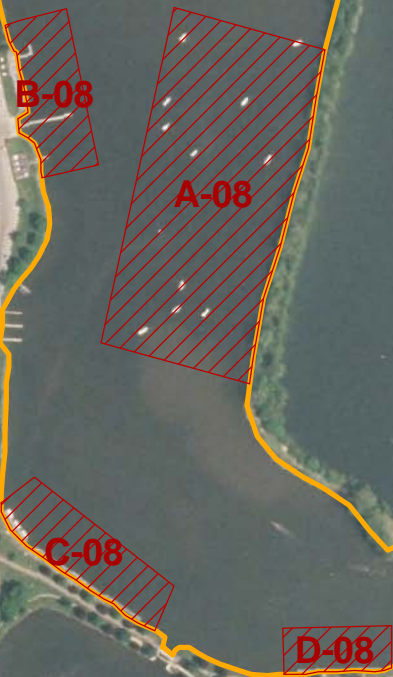
Site	GIS Acres	Permit Acres
A-08	8.3	10.3
B-08	1.5	0.9
C-08	1.6	1.5
D-08	0.8	1.1
<b>Total</b>	<b>12.1</b>	<b>13.8</b>

Map 5  
 Miller's Bay  
 Lake Winnebago  
 Winnebago County, WI  
**2008 Treatment Areas**
